Pharmaceutical Application Seal Problem

By: Katrina Mackey
Sales Manager
Colonial Seal Co.
Westville NJ

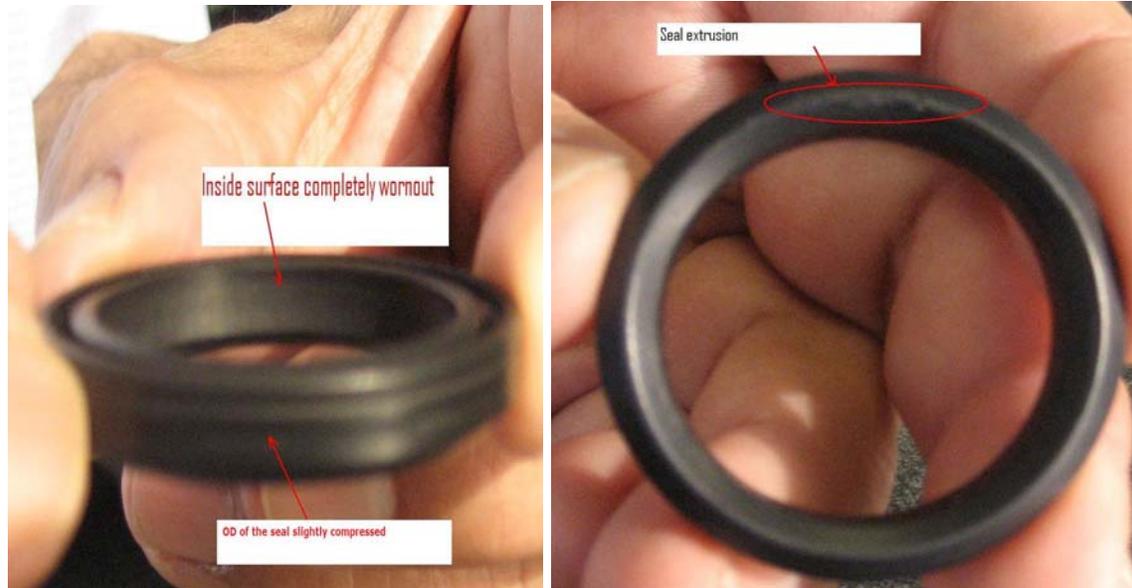
Acute visual analysis of the failed seals revealed a wear pattern that was circumferential in nature with slight blistering throughout the seal exterior. Excessive wear on the seal inner diameter was not uniform, and the heel of the seal was also deformed. Additionally, the edge of the heel, on the low pressure side appeared frayed and chipped. Other components of the extractor were also analyzed to determine if additional factors might have contributed to the seal failure. Shaft material and finish, housing bore condition, and the media were examined. For the purpose of this argument and for confidentiality reasons we cannot disclose the exact nature of the application, so we will only focus on the seal analysis and proposed solution.

Seal Lip Charring and Excessive Wear – This is an indication of heat degradation. Typical symptoms of heat degradation are a hard, brittle appearance of the seal. The seal may also show a breaking away of parts of the seal lip or body. Furthermore, the seal lip showed signs on being burnt as indicated by a deposit of a hard layer of carbon on a shaft seal's lip. The presence of carbon on the seal lip is a phenomenon called oil coking and comes about when the combination of high shaft speed and high temperatures create excessive under-lip temperatures. This increased temperature in turn burns and deposits the layer of carbon on the lip. This carbon crust blocks the pumping ability of the lip, making leakage inevitable. Another factor contributing to the effects of heat degradation is excessive lip loading. Lip interference is referred to as the difference between the diameter of a shaft seal's sealing lip and the diameter of the shaft to be sealed; interference is designed so that the lip diameter is smaller than the shaft diameter, thus ensuring the formation (and maintenance) of a contact point between the lip and the shaft. When excessive lip load is present it creates a situation where dynamic friction increases the underlip temperature.

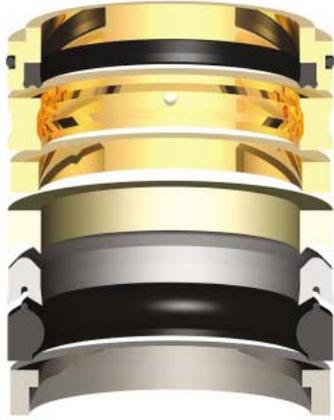
Plunger Packing Assembly

When we looked at all the elements contributing to the seal's failure, the engineer decided to go with a completely different design. This new design, similar to a plunger packing assembly, will combine several elements to address the seal's performance criteria. First, to address the seal wear and charring on the inner diameter of the lip required addressing the seal's radial lip force and the primary sealing lip material. The radial lip force is the sum of all forces, such as seal interference and garter spring tension that maintain contact between a shaft seal's lip and the shaft. This measurement should be just enough to seal without generating unnecessary friction and seal wear. In this instance, the excessive friction and high pressures combined to create an environment with excessive lip loading. The lip load issue was corrected by slightly increasing the seal ID and removing the stainless steel spring. This reduced the lip load so when the seal was operating under pressure the additional pressure did not cause any excessive loading of the lip against the shaft there by reducing the under lip temperature. Also, since the seal was operating in a non lubricated environment our engineer opted for a composite, lubricated, fabric reinforced HNBR header ring. Changing the lip material from PTFE to HNBR reduced the excessive wear occurring on the lip.

The packing assembly also featured a pressure ring made of a blended PTFE. The pressure ring was used to provide the packing assembly with the required pressure and temperature resistance.

To address the extrusion issue our engineer slightly increased the outside dimension of the backup ring adaptor combination. Since cylinders tend to expand when pressurized, the size of the extrusion device was recalculated to more tightly fit a clearance between the piston and the expanded cylinder. A female adaptor was constructed out of a PEEK and Glass fiber blend with an additional metal anti-extrusion ring of Aluminum Bronze. These two elements combined to form an anti-extrusion device with a higher tensile modulus that provided maximum extrusion resistance given the operating pressures. To prevent the HNBR header ring from extruding through the top of the stuffing box, we also added an aluminum bronze spacing ring to the top of the packing.

Overall, this plunger packing combination offered our customer reduced seal lip wear and friction at high operating speeds. In addition all the elements combined to provide a seal with superior extrusion resistance, thereby increasing seal life. If you have any questions on selecting the right materials for your unique application contact Colonial Seal Co. at sales@colonialseal.com. You can also visit our website www.colonialseal.com for further information on other product lines.
